82080108028
Project NY 512 023-1
Technical Note N-243
16 February 1956

technical note

EVALUATION OF ALUMINIZED STEEL MUFFLERS AND TAILPIPES

U. S. Naval Civil Engineering Research and Evaluation Laboratory
Port Hueneme, California

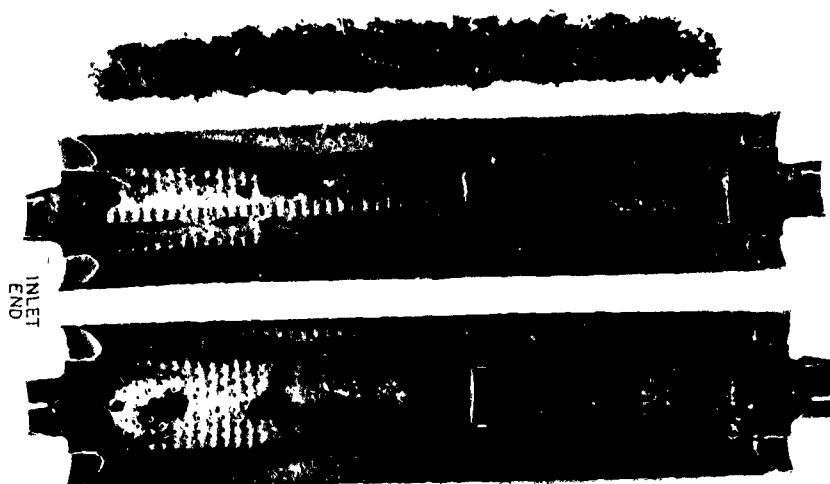
Figure 4. Aluminized muffler A bisected, showing internal scale before pickling.

Internal corrosion was substantial in both systems. No trace of the internal aluminum coating remained on the aluminized mufflers or tailpipe. From Figures 4, 5, 6 and 7 it can be seen that internal corrosion was heavier in the steel mufflers than in the aluminized mufflers. The effect of the internal aluminum coating in retarding corrosion was not proved in the tests of mufflers C and D since, as was explained in the section describing the muf-

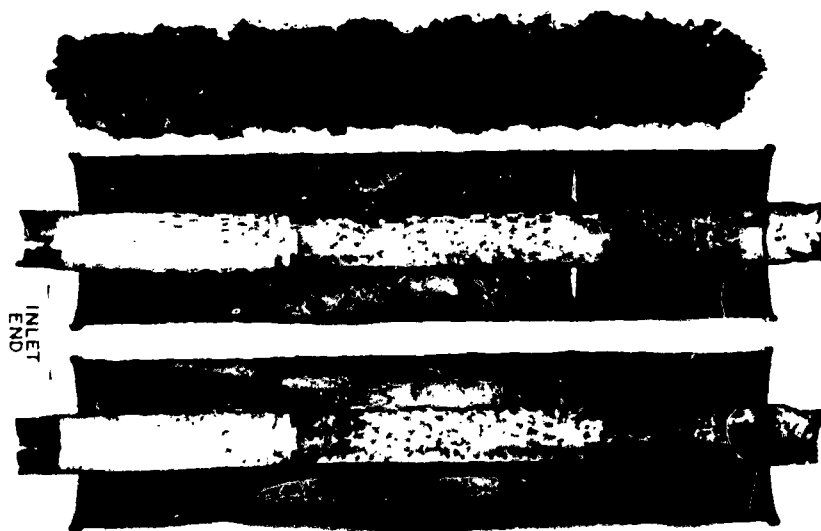
Figure 5. Steel muffler B bisected, showing internal scale before pickling.
